INDOOR AIR QUALITY ASSESSMENT

**Department of Revenue Office
218 South Main Street
Fall River, MA**

Prepared by:
Massachusetts Department of Public Health
Bureau of Environmental Health
Indoor Air Quality Program
August 2016

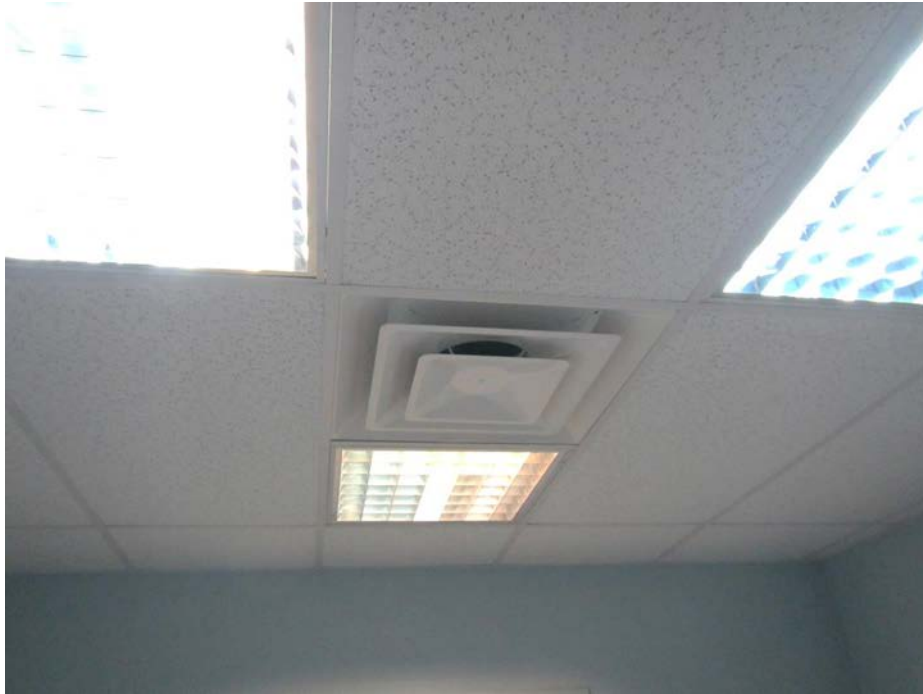
Picture 1

Fresh air is provided by air handling units (AHUs) located on the roof. Air from the AHUs is filtered, heated/cooled, and delivered to rooms via ducted supply vents (Picture 1). Air is returned/exhausted through return vents (Picture 2).

Supply vent

10. Clean supply and exhaust vents, personal fans, and heaters regularly to prevent aerosolization of debris.
11. Maintain air purifiers and filter changes in accordance with manufacturer's instructions.

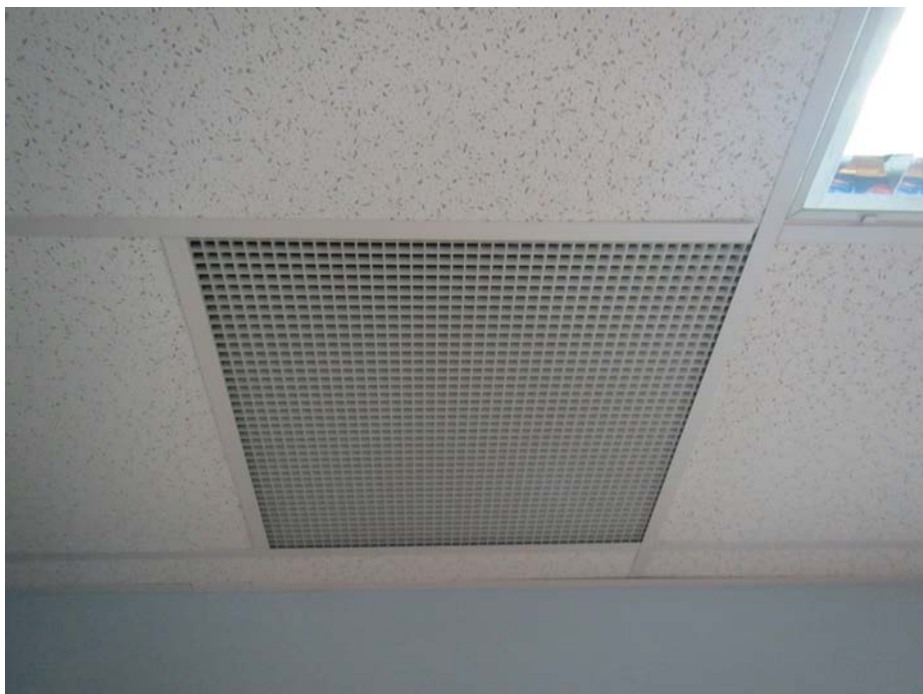
Picture 2

Return/exhaust vent

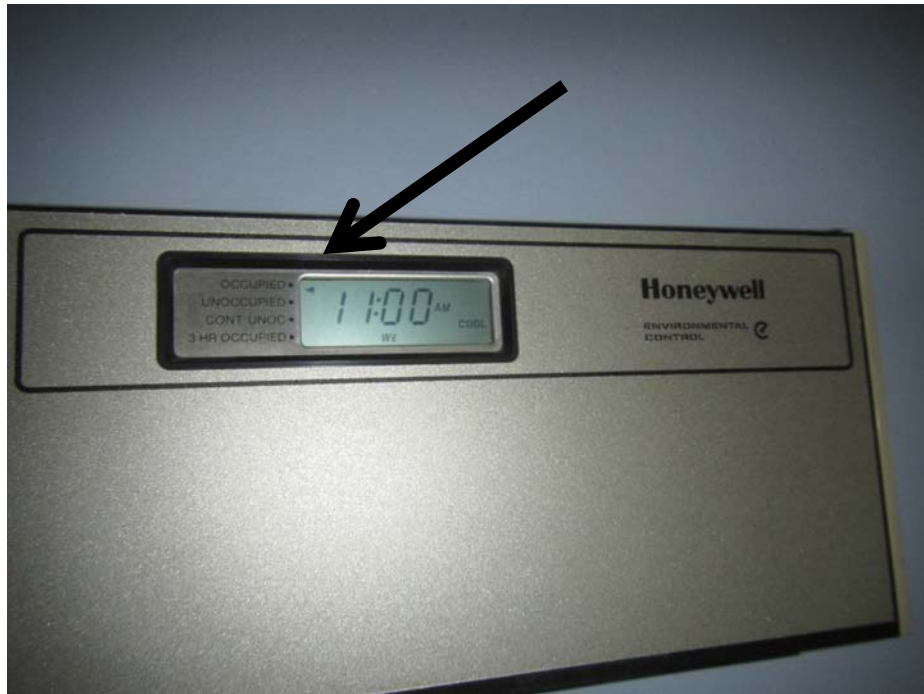
Picture 3

Thermostats in the office were observed set to the “occupied” setting (Picture 3) in most areas, with the exception of currently unoccupied “annex” storage area. The occupied setting

should provide continuous air circulation during occupied hours, even when no temperature adjustments are needed. If the annex is reoccupied in the future, this thermostat setting will need to be adjusted.

Thermostat set to “occupied” (arrow)

1. Operate supply and exhaust ventilation continuously in all areas during occupied periods. If the “annex” area is to be reoccupied, ensure that thermostat settings are adjusted to the occupied setting.

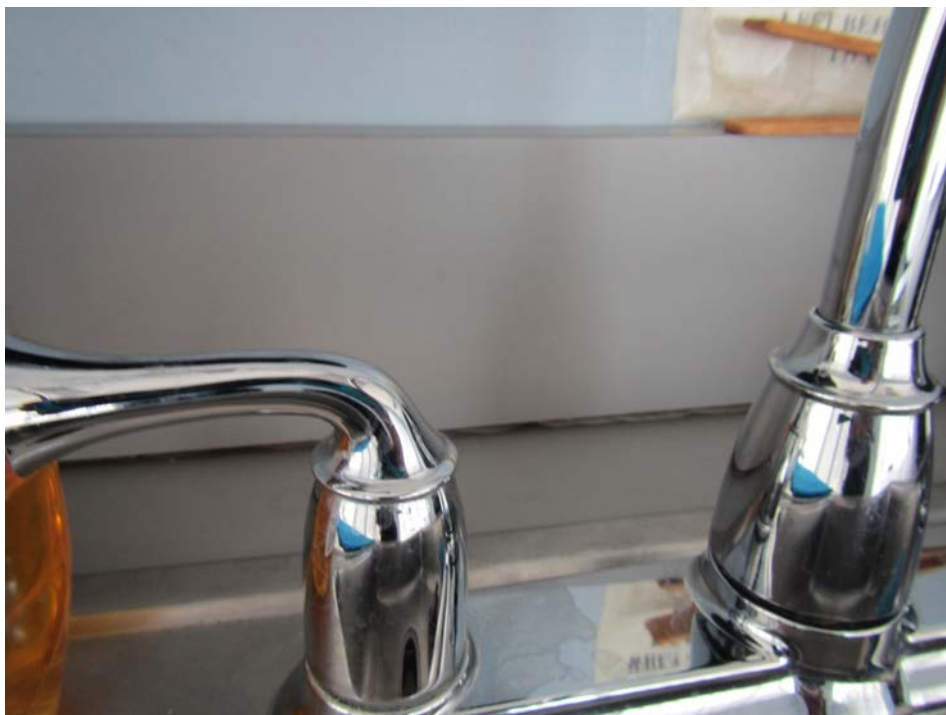
Picture 4

The backsplash behind the kitchen sink had a gap (Picture 4), which can allow water to damage the materials underneath/behind and potentially lead to microbial growth. Signs of water leakage or condensation were observed under the sink (Picture 5). Porous items stored under the sink can also become water-damaged.

Open gap on kitchen sink backsplash

2. Have the HVAC system balanced every 5 years in accordance with SMACNA recommendations (SMACNA, 1994).
3. Repair/seal the sink backsplash. Ensure sink is not leaking underneath and avoid storing porous materials under the sink.

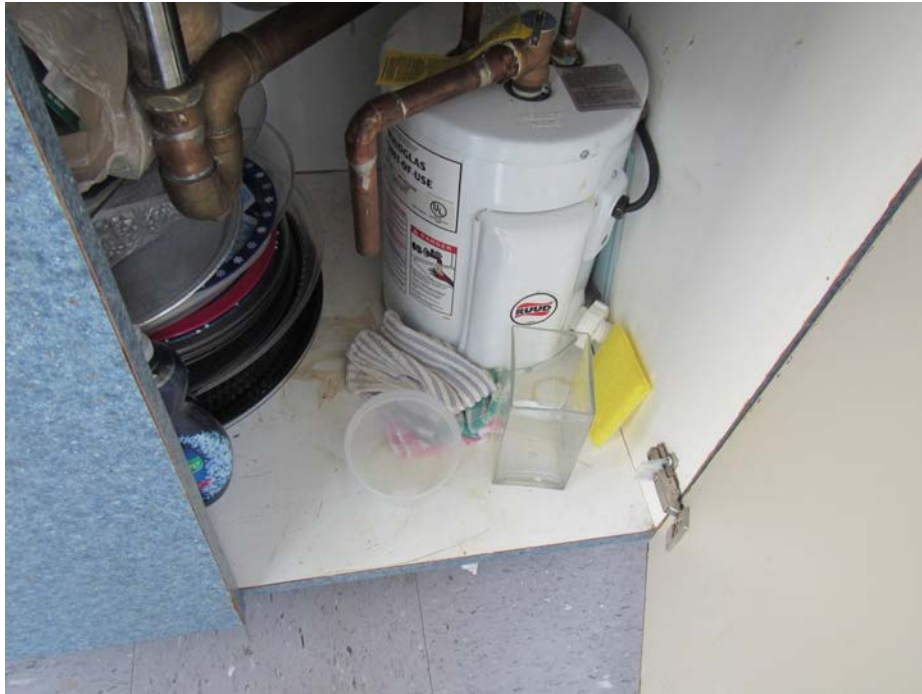
Picture 5

Water stains and porous items under sink

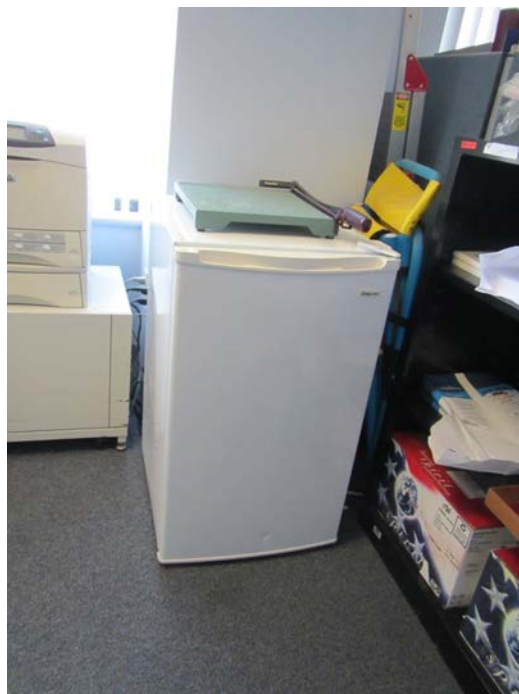
Picture 6

Several small refrigerators and water coolers were located in carpeted areas (Picture 6 and 7). Spills or leaks from these appliances can moisten the carpet, leading to odors and microbial growth. A gasket on a small refrigerator was found stained with debris/microbial growth (Picture 8). Refrigerators should be kept clean, and gaskets should be cleaned regularly with a mild antimicrobial solution.

Small refrigerator on carpet

4. Place refrigerators and water dispensing equipment in areas without carpeting or use a waterproof mat underneath them.
5. Ensure refrigerators including door gaskets are kept clean.

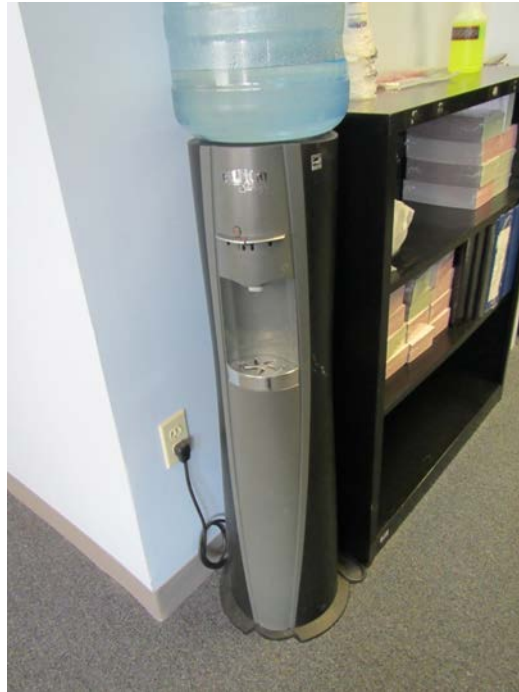
Picture 7

Water cooler on carpet

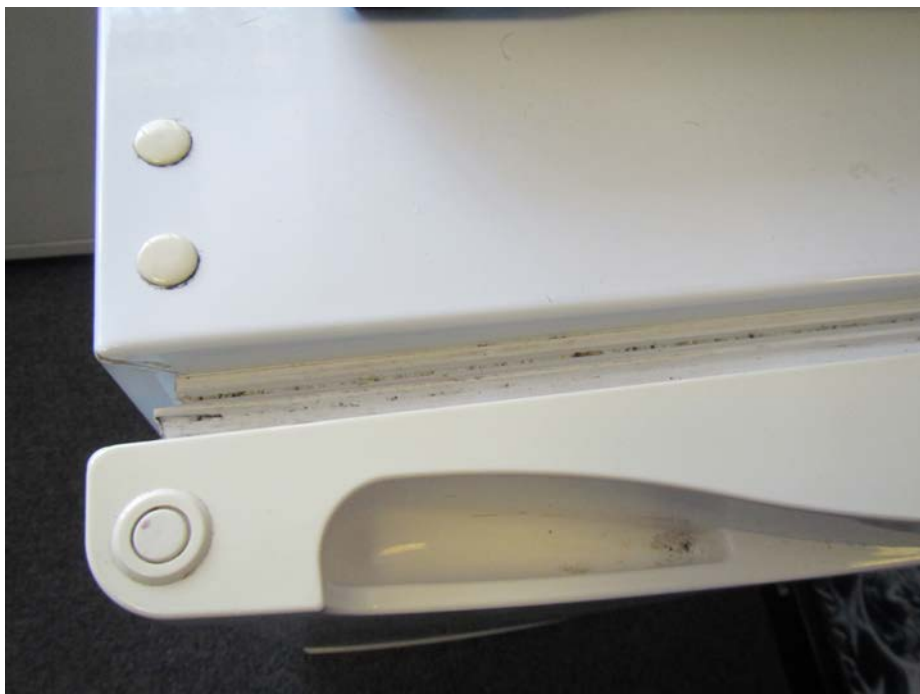
Picture 8

Stained refrigerator gasket

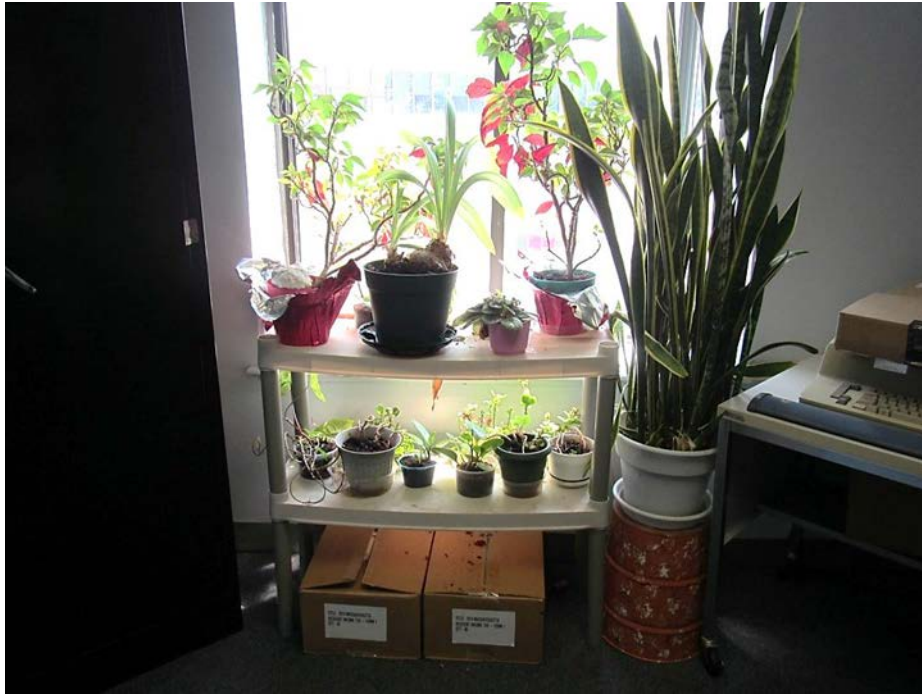
Picture 9

Plants were observed in offices (Picture 9; Table 1). Plants can be a source of pollen and mold, which can be respiratory irritants to some individuals. Plants should be properly maintained and equipped with drip pans to prevent water damage to porous materials. Plants should also be located away from air diffusers to prevent the aerosolization of dirt, pollen, and mold.

Plants, note debris on cardboard boxes stored underneath

6. Keep plants in good condition, avoid overwatering, and avoid placing them on porous items such as carpets or paper.
7. Reduce use of cleaning products, sanitizers, and scented products.

8. Clean carpeting in accordance with IICRC recommendations (IICRC, 2012).
9. Reduce stored materials and store in an organized manner to allow for thorough cleaning.
